IMPACT AND OPERATIONAL TESTS OF THE CONTAINER HOPPER

Technical Note N-1313

M. J. Wolfe and S. K. Wang

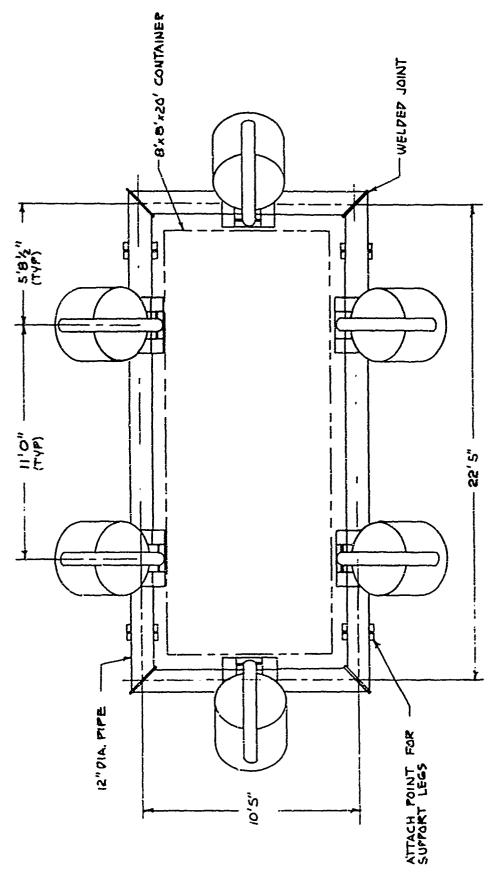
Figure 4. Arrangement of bumpers on pipe support frame (plan view).

The top, as illustrated in Figure 4, consists of six bumpers mounted on a rectangular frame. As shown in Figure 5. each bumper consists of a curved pipe which pivots about its lowest point. The rotating motion of the arm is restricted by a dampening device constructed of two truck tires. The truck tires are bolted to each other, the lower tire bolted to the fixed inclined plate, and the upper tire bolted to a similar plate on the arm.

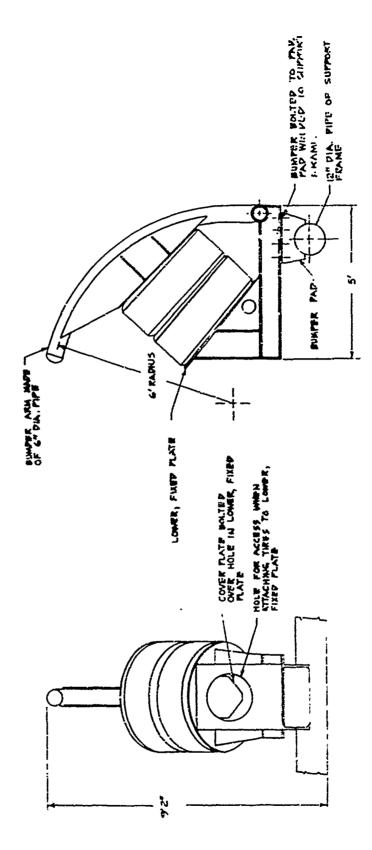
NOTE: TIRES ARE SUPER SINGLE TRUCK THES 18-22.5, M. PLY RATING 2. APPROXIMATE TOTAL WEIGHT OF ONE BUNFBET, 1800 FOUNDS.

Figure 5. Details of hopper bumpar.

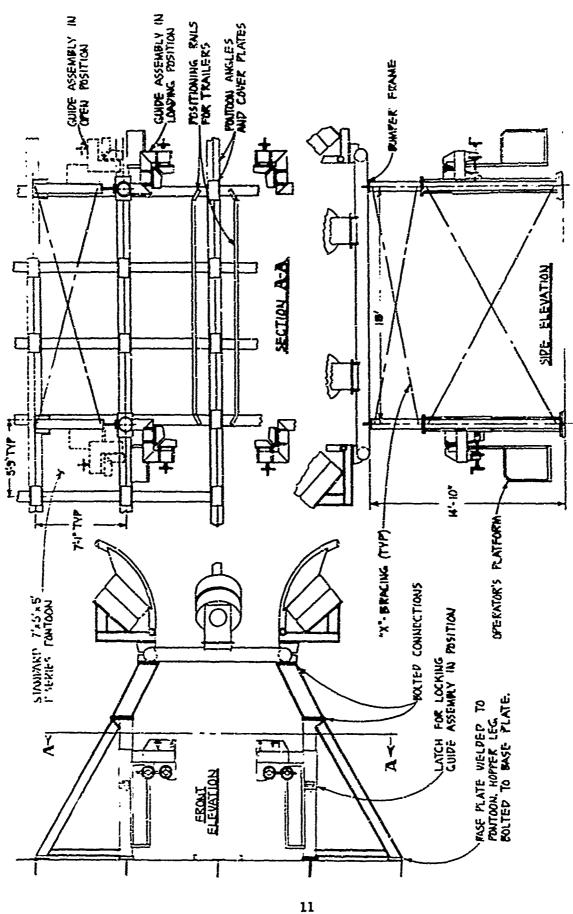
Details of hopper mounting on 7x15 barge. Figure 7.

Each of the guide assemblies is equipped with an operator's platform, shown in Figure 7. Without the platform, shorter operators may have some difficulty turning the adjusting screws, which are over five feet above deck level. Also, it is easier for the operator to see the twist locks on the MILVAN chassis when he is elevated slightly.

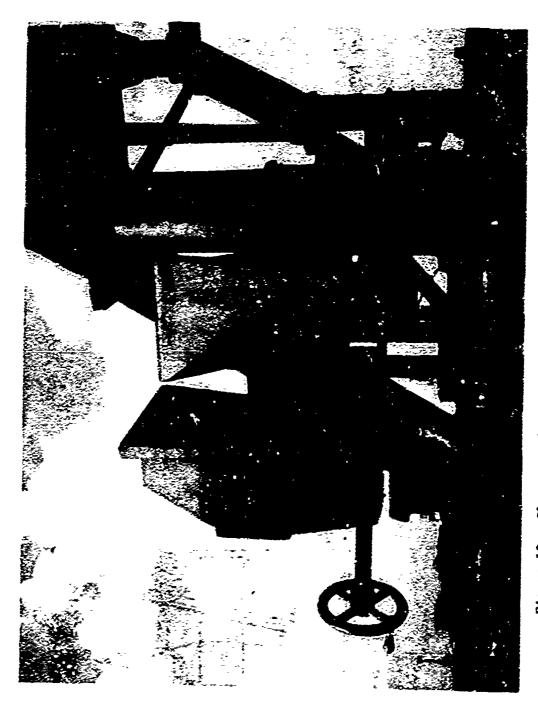
Figure 10. Close-up of one of the fine positioning assemblies. The armombly is in the "open" position.

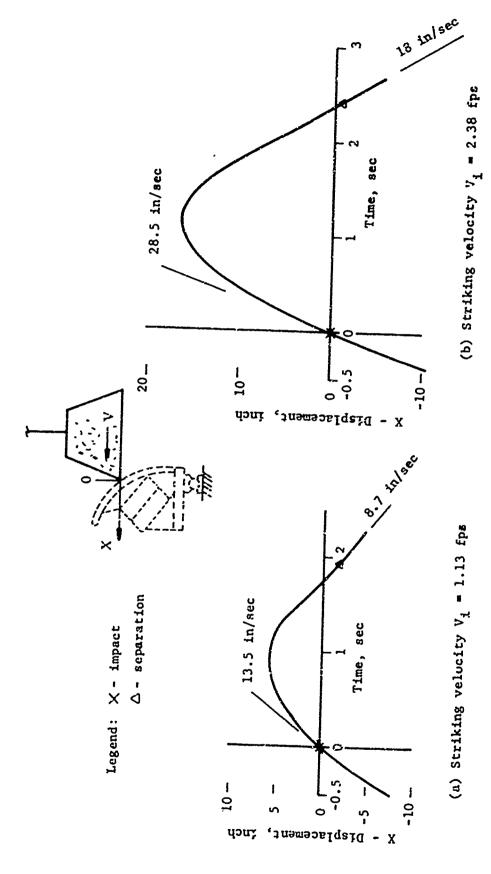
Figure 13. Displacement history of striking weight.

Figure 13 shows a plot of the actual measured velocity of the corner of the load (point A) during the impact tests in which the initial striking velocity was 3.27 fps. Also, plotted in Figure 18 is the theoretical velocity of the center of gravity of the concrete block if it were allowed to swing back and forth as a simple pendulum starting from the initial condition. In other words, the measured velocity of point A shows what happened to the load hitting the bumper, while the theoretical curve shows what would have happened if there were no bumper.

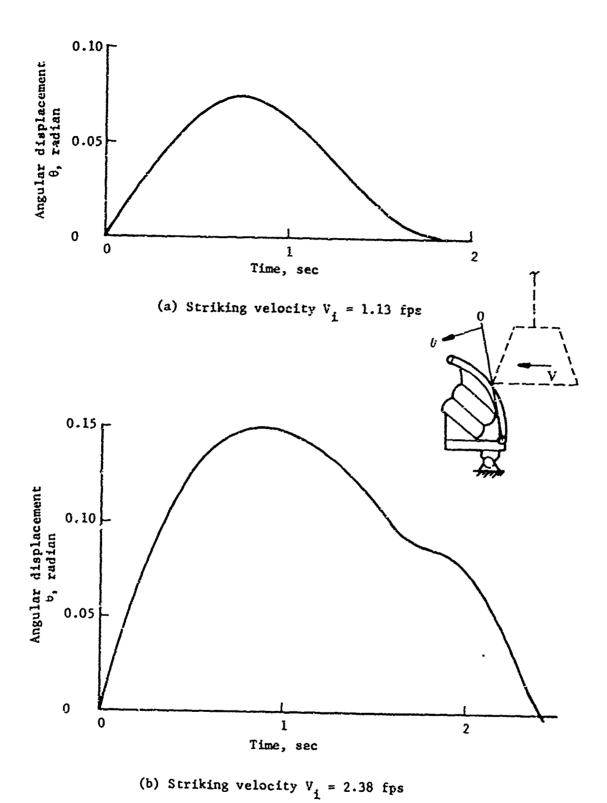
Figure 14. Angular deflection history of hopper arm.

Three tests runs were conducted at this velocity. The weight was displaced 42 inches from its equilibrium position. Data reduced from one such test run showed an impact velocity V_i = 2.38 fps; a separation velocity V_s = 1.5 fps; a maximum arm rotation 0.15 radians, and a time duration of 2.4 seconds from impact to separation. Again, there was no rebound, but the load slid about 10" up the arm from the point of impact. No physical damage was observed on the load and arm. It is interesting to note that the arm dwelled about 1/4 of a second during its recovery rotation as the load slid downward. The dwelling was believed to be a combined result of weight rotation and deflection characteristics of the shock absorbing mechanism (Figure 14). A ratio

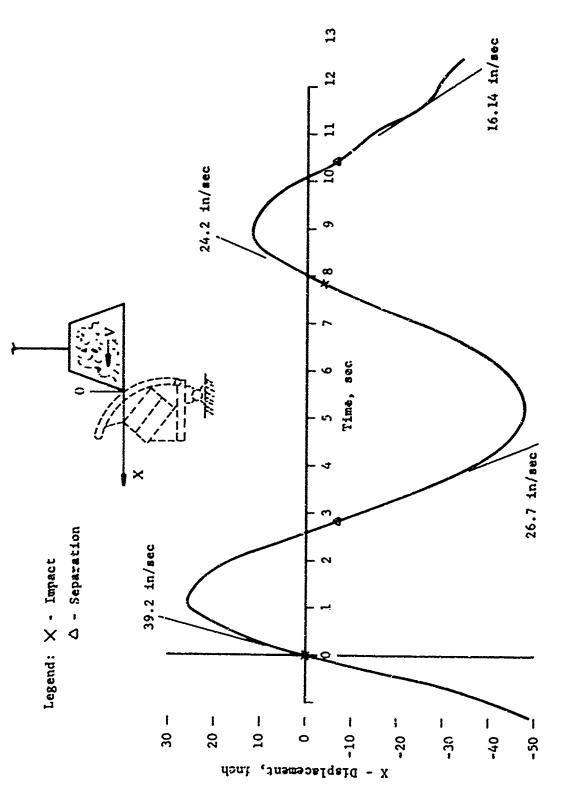
Figure 15. Displacement history of striking weight V_{χ} = 3.27 fps.

Runs of $V_i = 3$ fps (Figures 15 and 16)

There were five tests runs at this impact velocity. The weight was displaced 62.5 inches from its equilibrium position before being released. Data reduced from one such run showed an actual impact velocity of $V_{\rm i}=3.27$ fps; a separation velocity of $V_{\rm s}=2.23$ fps; a maximum arm rotation of 0.22 radians; and a time duration of 2.85 seconds from impact to separation.

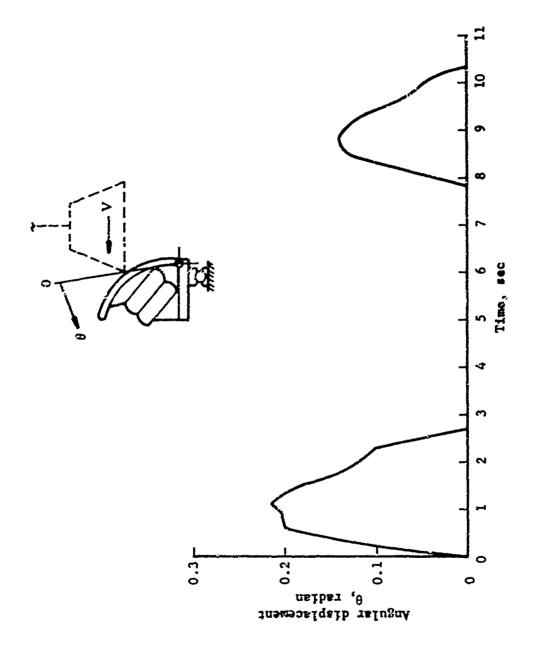
Figure 16. Angular deflection history of hopper arm - $V_{\rm L}$ = 3.27 fps.

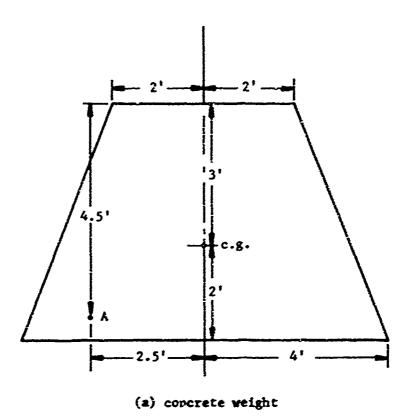
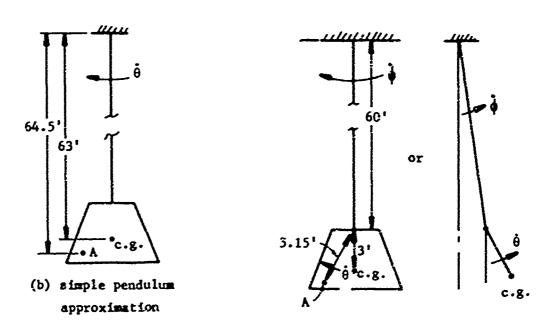
Figure 17. Specifications of weight and supporting cable.

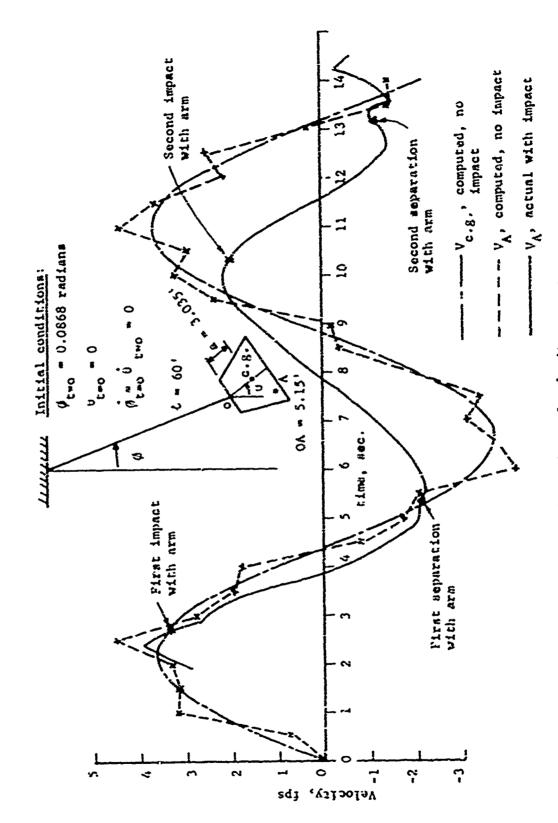
Figure 18. Comparison of velocity curves.

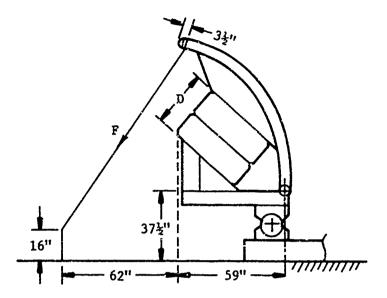
F, 1bs	D, in
0	36
250	35-3/4
500	34-3/8
1,000	30
1,500	27
1,725	24-3/4
2,000	23
2,500	21-5/8
3,000	20-3/8
3,500	18-3/4
3,500	13-1/4

Figure 19. Setup for hopper arm calibration.

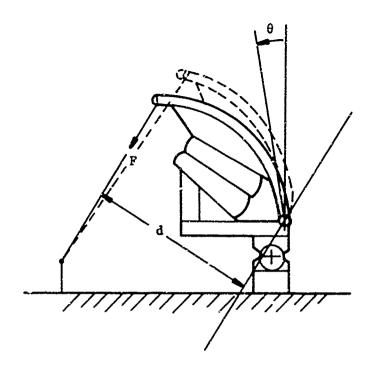
F, 1bs	d, in	M = Fd, in-1b	θ, Radian
0	87.4	0	0
500	87.7	43,850	0.021
1,000	89.2	89,200	0.091
1,500	90.0	135,000	0.136
2,000	91.3	182,600	0.199
2,500	91.6	229,000	0.220
3,000	92.0	276,000	0.238
3,500	92.4	323,400	0,262
3,500	93.2	326,200	0.349

Figure 20. Data of hopper arm calibration curve.

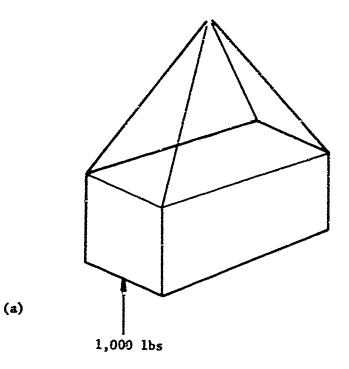
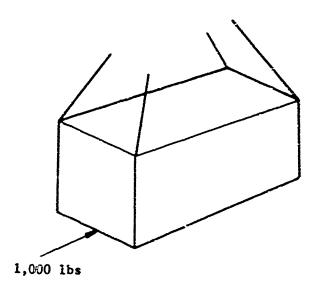
Figure 24. Load cases.

The stresses caused by the unit leads were multiplied by the appropriate factor to give actual stress. The multiplication factors were determined by resolving the force of the bumper arm on the container into horizontal and vertical components. These stresses were added to the stresses caused by the floor lead, using the principle of superposition and assuming elastic behavior of the structural members of the container.

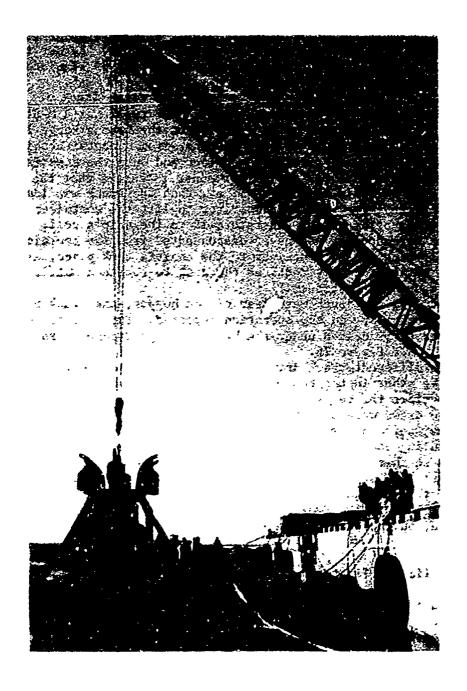
Figure 26. Loading operation during the first day of hopper operations during OSDOC II.

Once the container was clear of the hopper, the truck backed up onto the causeway and the operation repeated. This ensured that the truck had to be driven under the hopper and positioned before the next loading. See Figure 26.

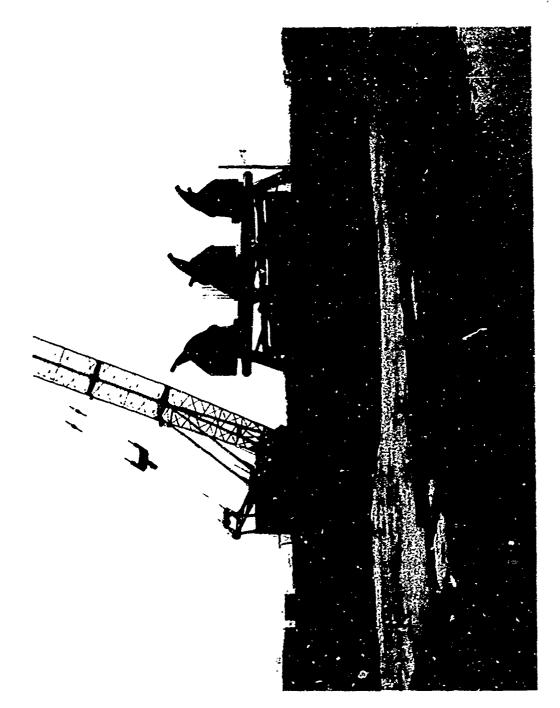
Figure 28. Test setup for post-OSDOC II tests.

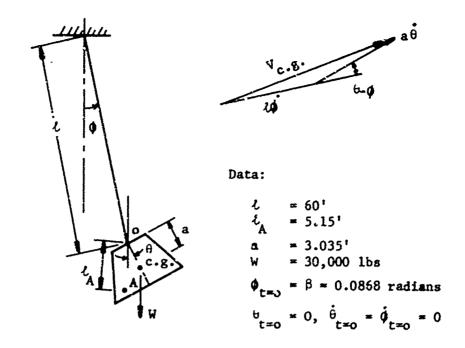
Figure A-1. Pendulum with 2-degrees of freedom.

(c) pendulum with 2-degrees of freedom
